OKAYDY RESERVOIR DAM  
HOWARD COUNTY, MISSOURI  
MO. 10001

# PHASE 1 INSPECTION REPORT NATIONAL DAM SAFETY PROGRAM

JUNE, 1979

PREPARED BY  
HOSKINS-WESTERN-SONDEREGGER, INC.  
CONSULTING ENGINEERS  
LINCOLN, NEBRASKA

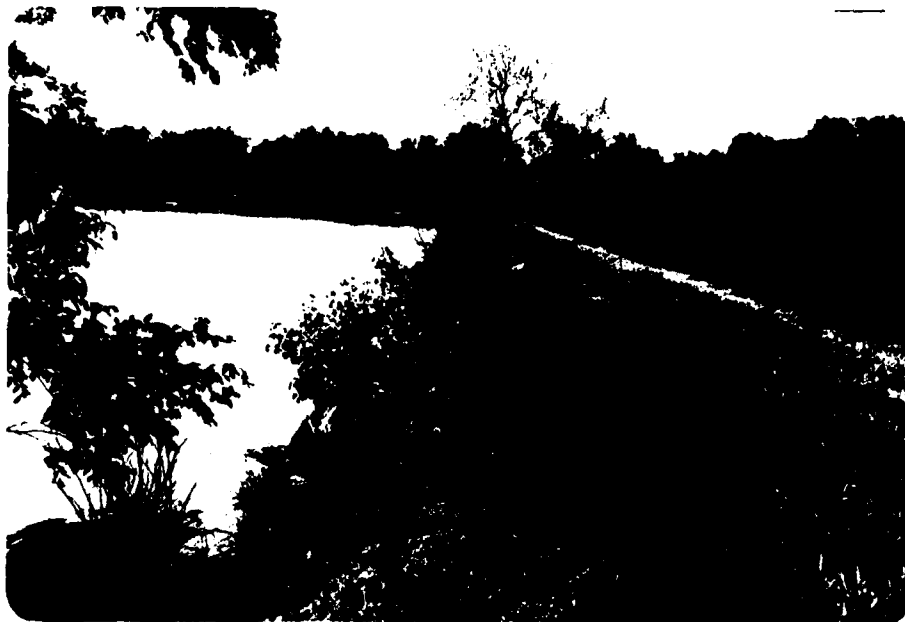
PHOTO NO. 2 - VIEW OF UPSTREAM SLOPE FROM RIGHT ABUTMENT.

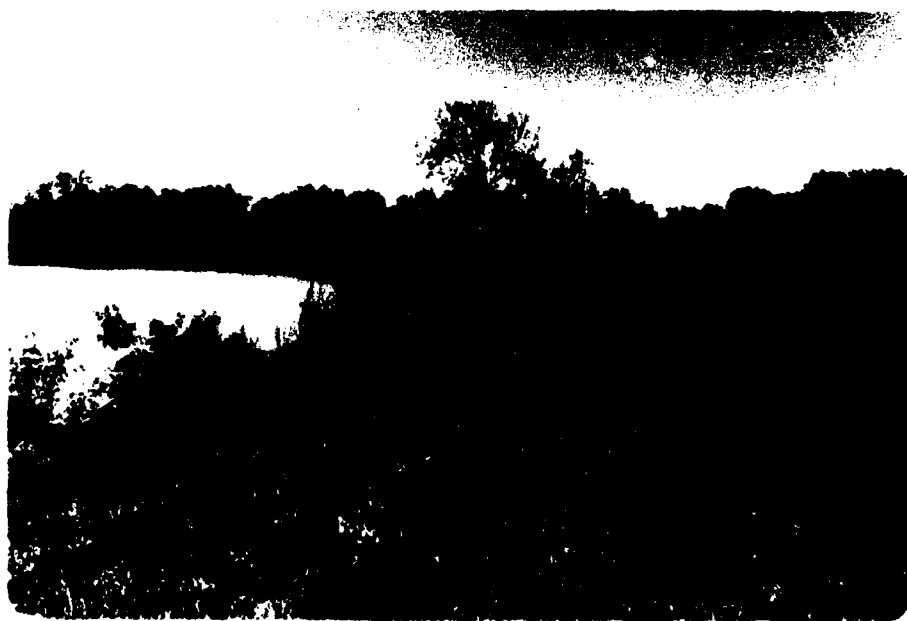
PHOTO NO. 3 - VIEW OF CREST FROM RIGHT ABUTMENT.

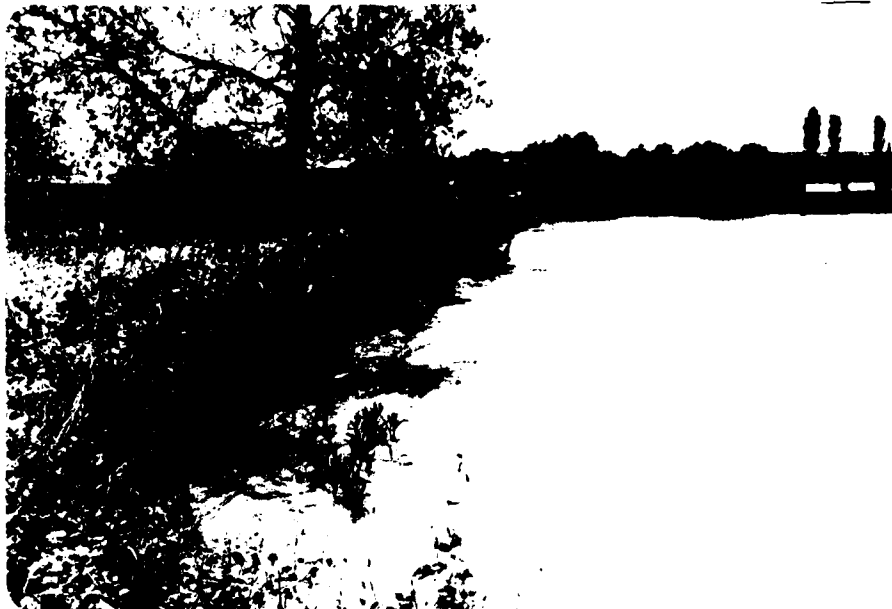
- (2) Upstream Slope. The upstream face slopes on 2.2 to 2.5H on 1V from the crest elevation down about 3 feet (elev. 618 feet  $\pm$ ) where it breaks to near vertical to the water surface at elevation 615.2 feet. Some riprap consisting of old concrete slabs and rubble was observed at or just above the water line. The slope above the riprap is fairly well vegetated with grass. A few small trees and shrubs are growing along the water line. Some erosion is noticeable above the riprap and two areas near Stations 2 + 10 and 1 + 20, show significant erosional damage with material removed almost to the crestline (see Photos 5 and 6).

PHOTO NO. 6 - ERODED UPSTREAM FACE AT STA. 1 + 20±.

- (1) Trees and shrubs should be removed from the upstream face of the dam and measures taken to prevent their recurrence.
- (2) The beaver dam, trees, and shrubs should be removed from the inlet of the spillway.
- (3) Obstructions (trees, etc.) should be removed from the outlet channel of the spillway to the extent that the spillway will operate effectively under the design flood.
- (4) Erosion on the upstream face should be corrected and measures taken to stabilize the slope with riprap or other means.
- (5) A program of regular inspection and maintenance should be initiated to control vegetative growth and erosion on the embankment slopes and to eliminate or control the beaver activity.

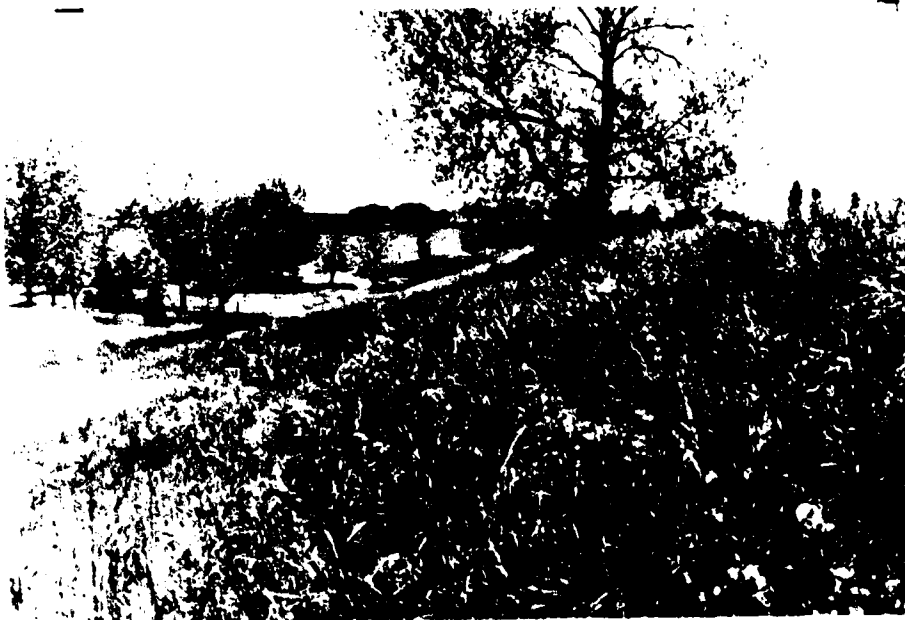
- (3) Crest - The crest is well vegetated with adapted grasses and was recently mowed. One large tree is growing on the downstream crest line near station 2 + 00. This tree was evidently left in place when the dam was enlarged in 1954. The profile of the crest is fairly uniform with one slight depressional area (0.3 to 0.5 ft. low) around Station 2 + 00. No cracks, rodent holes or lateral deformations were noted.

PHOTO NO. 10 - DOWNSTREAM SLOPE FROM LEFT END.  
NOTE LONE TREE.
